# **flare prevention/minimization assessment**

**Chevron Richmond Refinery  
December 31, 2024**

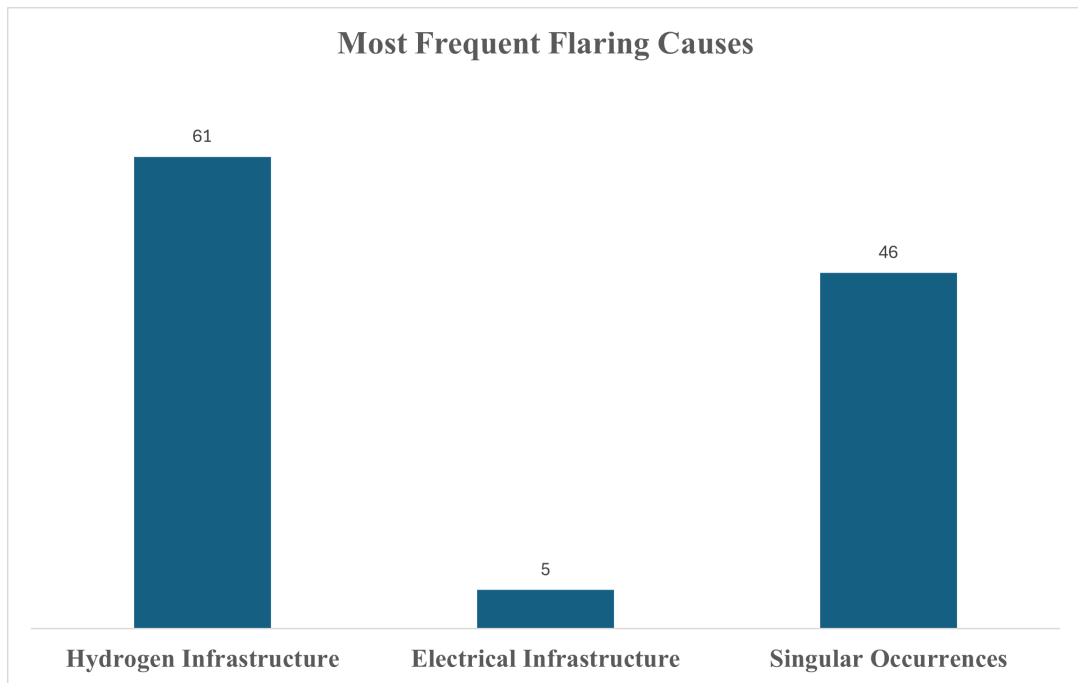
Figure 1: The most frequent flaring causes (February 2018 – May 2024)

As summarized in Figure 1, the review of reportable flaring events identified hydrogen (H<sub>2</sub>) infrastructure reliability and electrical infrastructure reliability as the two areas with the highest related causes of flaring. Other causes of flaring analyzed in this assessment were categorized as singular occurrences where the root causes and contributing factors were adequately addressed with corrective actions and preventative measures following the specific event.

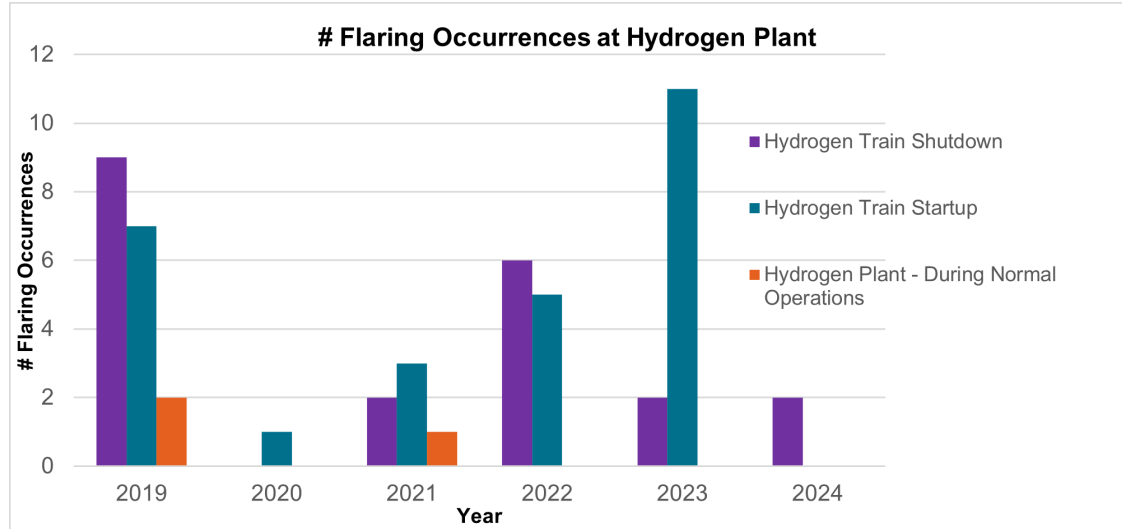
Figure 2: Reportable flaring incidents at H2 Plant (2/2018 – 5/2024).

As outlined in Figure 2, most reportable flaring events at the H2 flare were primarily attributed to the startup and shutdown activities of the H2 trains, with only three flaring events occurring while the H2 plant was in normal operation. However, H2 infrastructure reliability issues caused the H2 plant to have an increased rate of unplanned shutdowns (and subsequent start-ups) during the review period, with the highest frequency during the initial commissioning years of the H2 plant. The annual frequency of reportable flaring events caused by H2 plant shutdowns resulting from equipment failures has been decreasing since the installation of the H2 plant (see Figure 3). This improvement trend aligns with the Richmond Refinery's H2 infrastructure reliability improvement project initiatives outlined in Section 4.

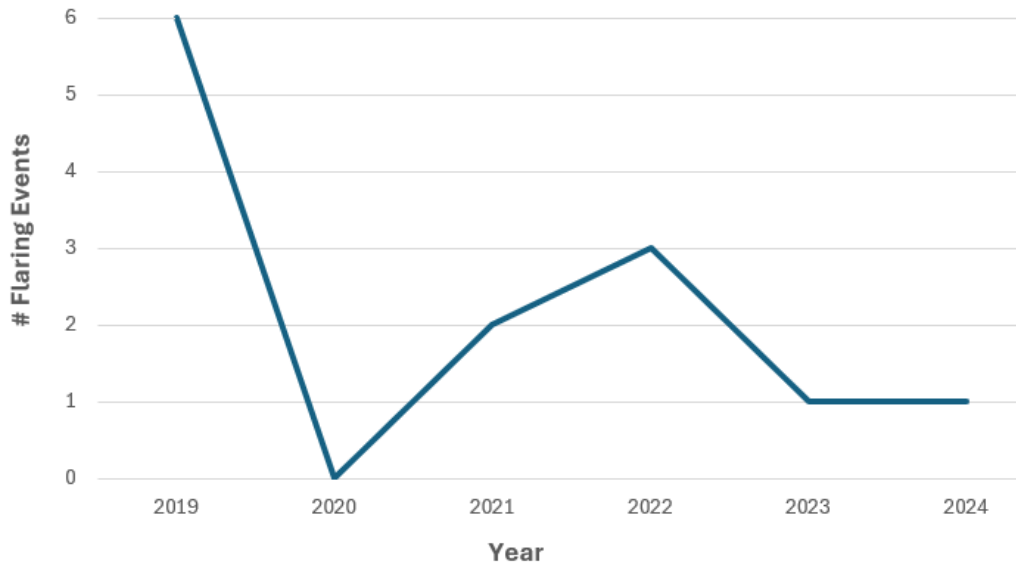
**Figure 3: Flaring events from hydrogen plant shutdown caused by equipment failure (as opposed to planned shutdowns)**
