**Chevron Richmond Refinery  
February 2025 Flaring Causal Analysis Report**

Causal Analysis Report

Chevron Richmond Refinery  
Reportable Flaring Events

## Refinery Flare Event – Cause Investigation Report

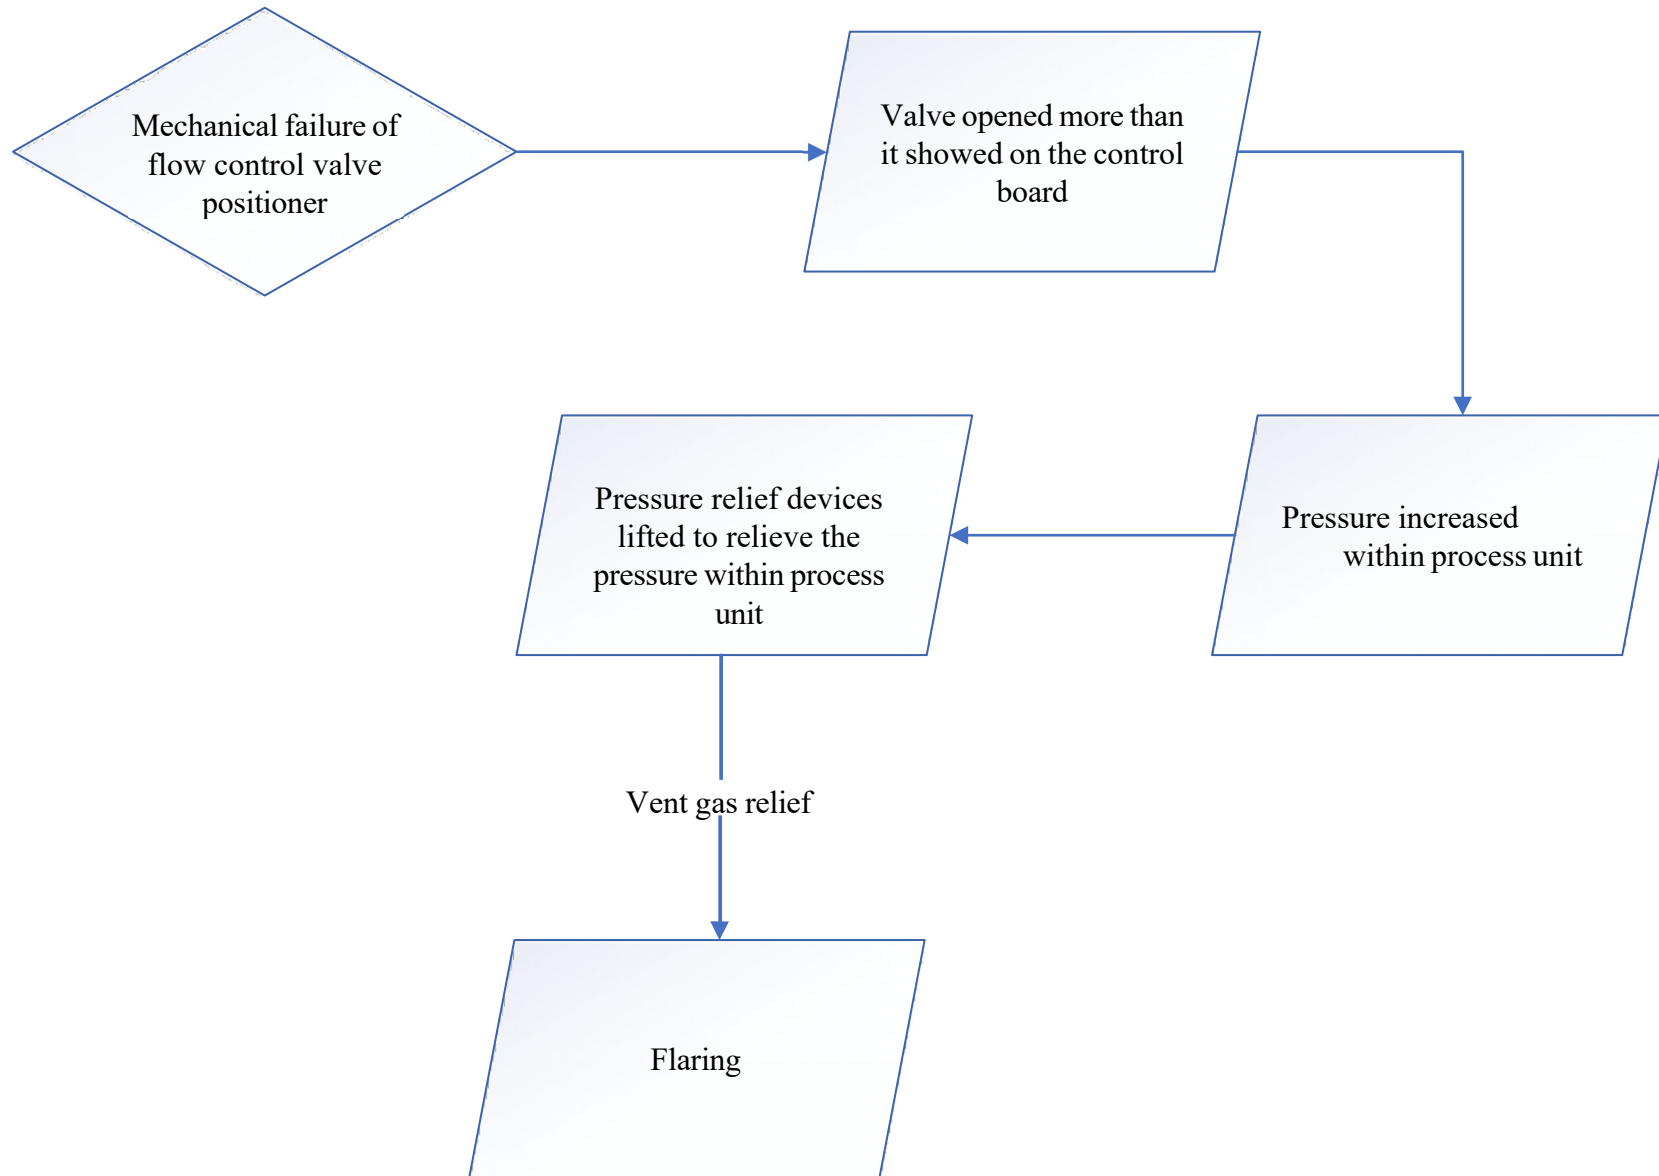
### Attachment Ia: Flaring Due to Mechanical Failure of a Control Valve Positioner

On February 1, 2025, during a unit startup, the failure of a flow control valve positioner failed, which led to the valve opening more than it showed on the control board, causing a pressure increase within a process unit. The pressure relief valves on the impacted unit opened to relieve the pressure, thereby resulting in the flaring event.

Primary causal factor: Mechanical failure of a control valve positioner

The control valve was placed on bypass control to facilitate the replacement of the control valve positioner. Following the completion of the replacement, the system resumed normal operations, resulting in the cessation of flaring.

1. Evaluate and consider installing valve diagnostic software that gives an early indication of positioner failure and position feedback on critical control valves within the impacted process unit. Estimated Completion Date: 12/01/2025

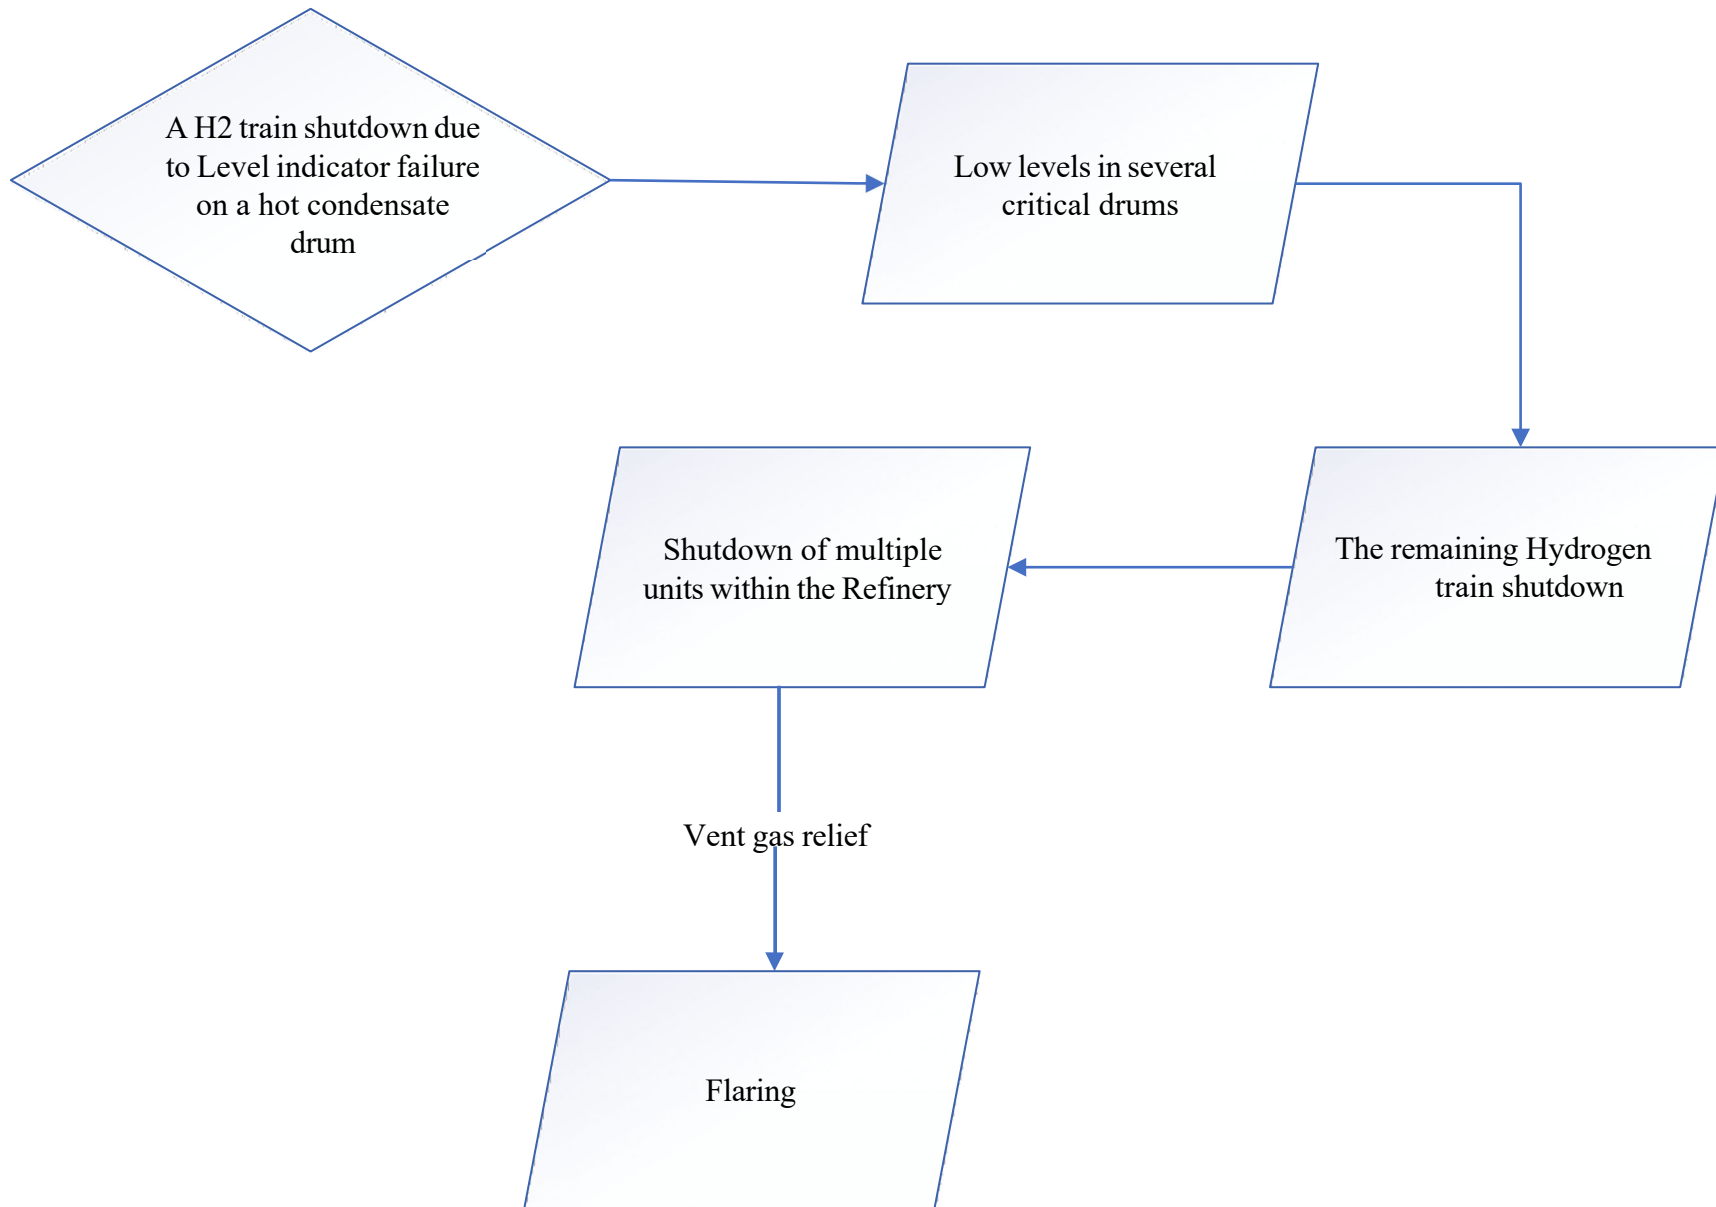
## Attachment IIa: Flaring Due to Failure of a Condensate Drum Level Indicator

On February 2, 2025, a Hydrogen train tripped offline due to a failed level indicator on a hot condensate drum, which resulted in a series of level excursions. This failure resulted in low levels in several critical drums, which caused instability at the hydrogen plant. Consequently, the remaining hydrogen train also tripped. The loss of both Hydrogen trains caused a significant reduction in steam load, leading to the shutdown of multiple units within the refinery and resulting in the flaring event.

Primary causal factor: Failure of a condensate drum level indicator

1. Upgrade level instruments for the critical condensate drums at the Hydrogen plant.  
Estimated Completion Date: 08/31/2025

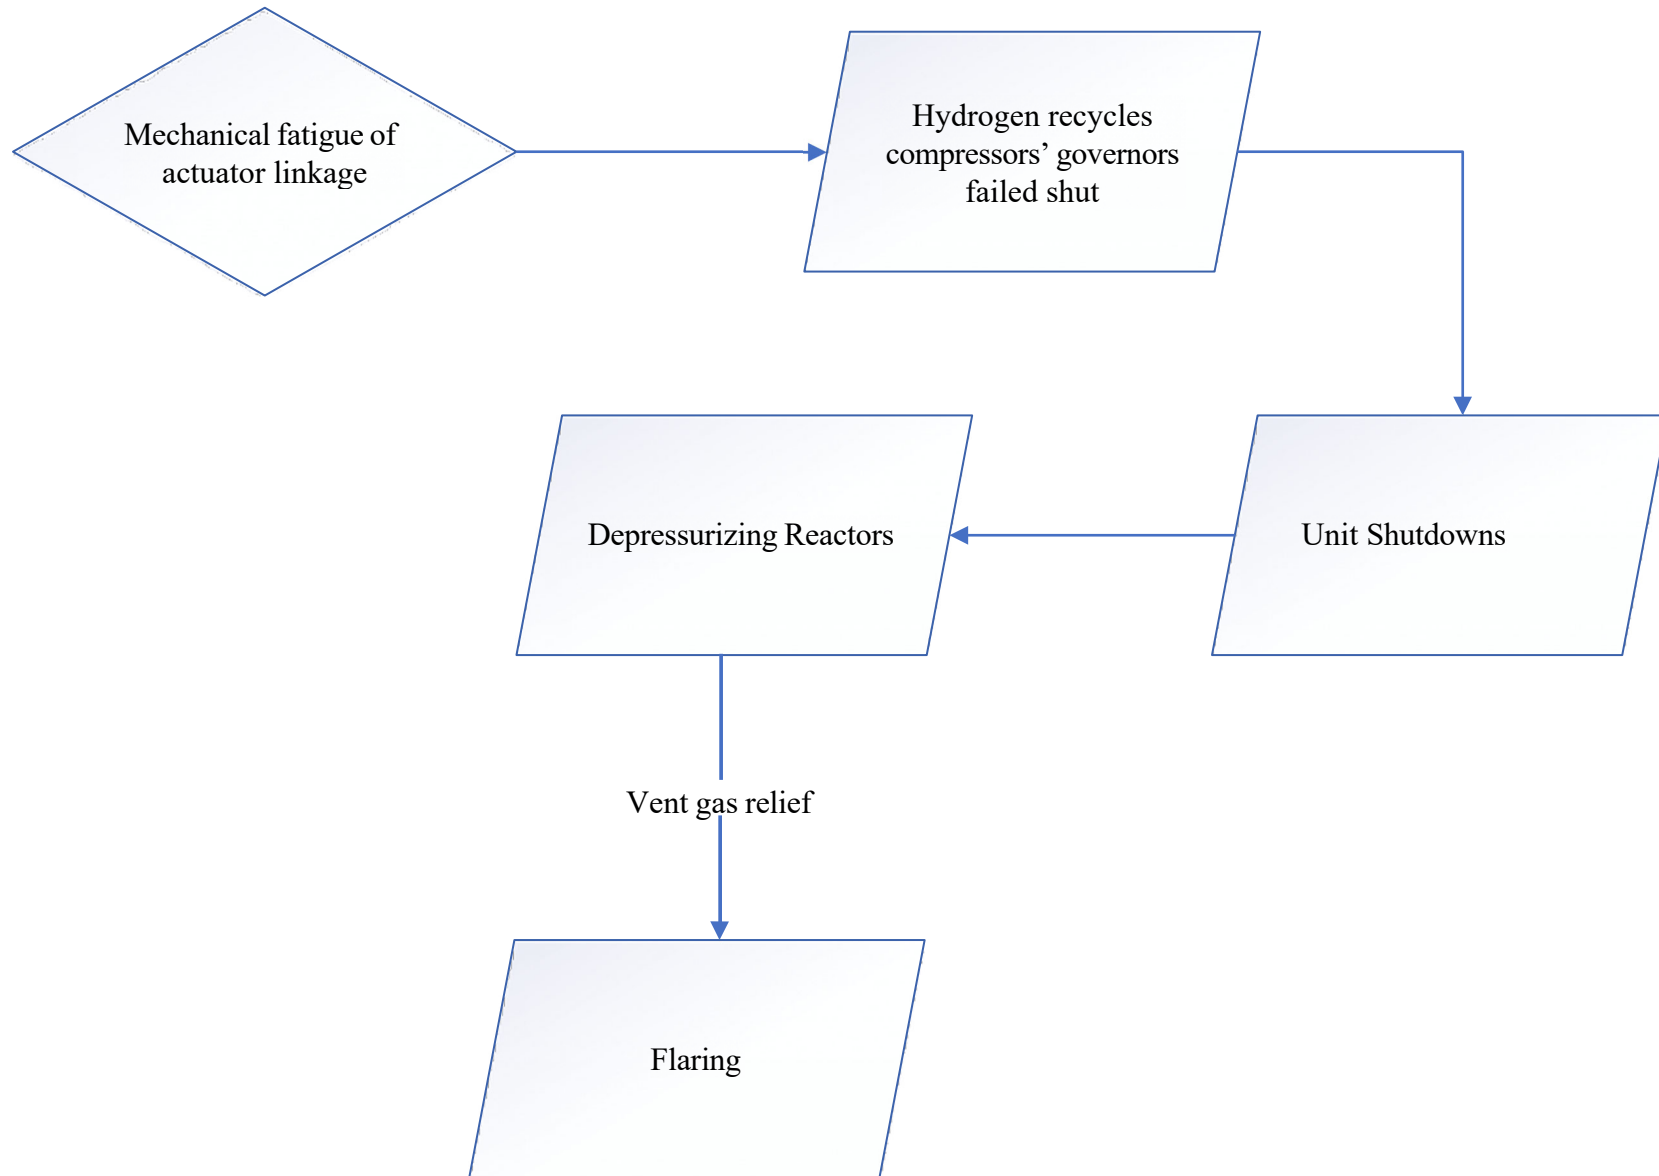
# Attachment IVa: Flaring due to mechanical fatigue of actuator linkage

On February 08, 2025, a malfunction occurred on a Hydrogen recycle compressor due to mechanical fatigue of the actuator linkages during startup activities in the process units. This failure necessitated pulling feed and subsequently shutting down the units. As a result, the reactors had to be depressurized, which exceeded the flare gas compressor capacity and led to the flaring event.

Primary causal factor: Hydrogen recycle compressors failed shut due to mechanical fatigue of the actuator linkage

1. Upgrade linkage components for the impacted hydrogen recycle compressor to a more robust design with more mechanical advantage.  
Estimated Completion Date: 11/30/2025
2. Evaluate to consider re-designing governor system for unit recycle compressors to improve speed control performance.  
Estimated Completion Date: 03/31/2026
