**Chevron Richmond Refinery  
June 2025 Flaring Causal Analysis Report**

Causal Analysis Report

Chevron Richmond Refinery  
Reportable Flaring Events

Flaring Due to Malfunction of Pressure Indicator at Hydrogen Plant Train

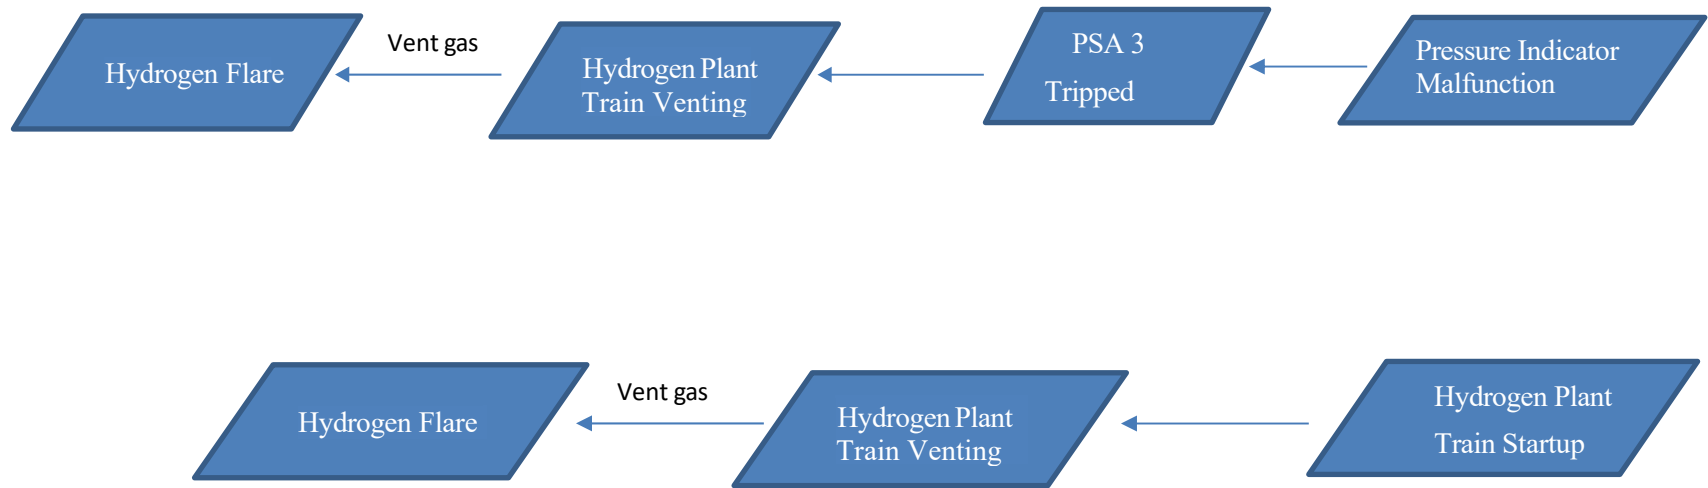
## **Attach Ia: Flaring Due to Malfunction and Startup of Hydrogen Plant Train**

On June 6, 2025, PSA 3 at the Hydrogen Plant tripped offline due to a malfunction of a pressure indicator. The indicator faulted to high scale, which caused the trip. The unit was stabilized and the pressure indicator was replaced. The unit was restarted on June 7, 2025 at about 1:42 and flaring during start-up lasted 8 minutes.

Primary causal factor: Malfunction of a Pressure Indicator that could not be foreseen.

The primary contributor of the vent gas to the flare was the Hydrogen Plant Train PSA 3 trip.

Operations immediately proceeded to repair/replace the pressure indicator. Once repaired, Operations proceeded with the startup activities per the procedure to reduce any associated emissions. The Hydrogen Plant does not have flare gas recovery.

The event was an unforeseen malfunction of the pressure indicator. The work to replace the indicator was done immediately, the unit was stabilized, and Chevron restarted the unit as soon as possible. Flaring cannot be prevented during Hydrogen Plant startup due to facility and relief system design. Operational activities were consistent with shutdown procedures.
