**Chevron Richmond Refinery
May 2025 Flaring Causal Analysis Report**

Chevron Richmond Refinery
Reportable Flaring Events

Refinery Flare Event – Cause Investigation Report

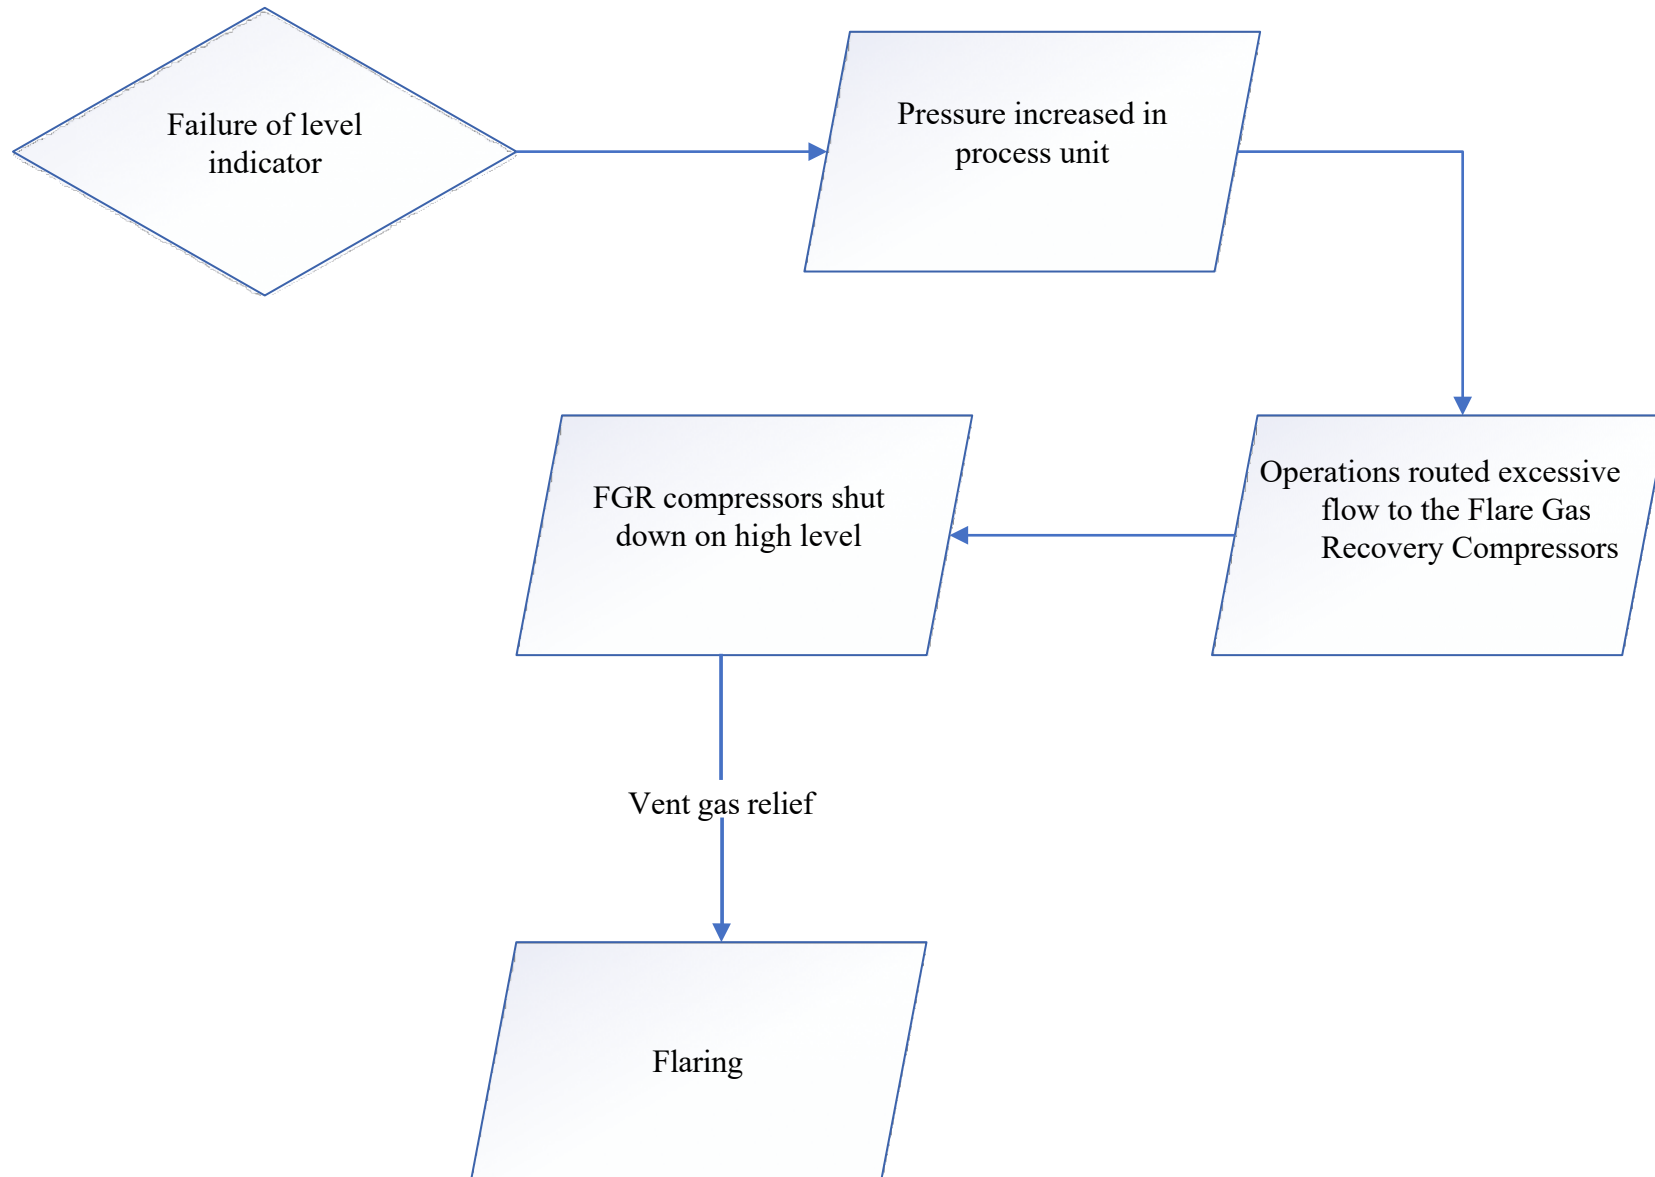
Attachment Ia: Flaring Due to Mechanical Failure of a Control Valve Positioner

On May 5th, 2025, a Gas Recovery Unit experienced an over pressure situation that led to flaring. The process system had an increase in pressure due to faulty instrumentation requiring operations to route excess flows to the relief system. This caused the flare gas recovery compressors to shut down on high level and flaring occurred.

Primary causal factor: The level instrumentation failed due to plugging.

- Flare gas recovery(FGR)knock out drum's pump was cavitating.
- The normal blowdown line of the FGR discharge knockout drum was out of service

1. Repair the level instrumentations and develop critical checks and testing prior to startup to validate correct functionality for the critical instruments. Estimated Completion Date: 07/30/2025
2. Install a cross-tie from a reciprocating pump to the outlet of the FGR knockout drum. Estimated Completion Date: 12/30/2025
3. Repair or replace blowdown line from the FGR discharge knockout drum to the relief knockout drum. Estimated Completion Date: 08/30/2025

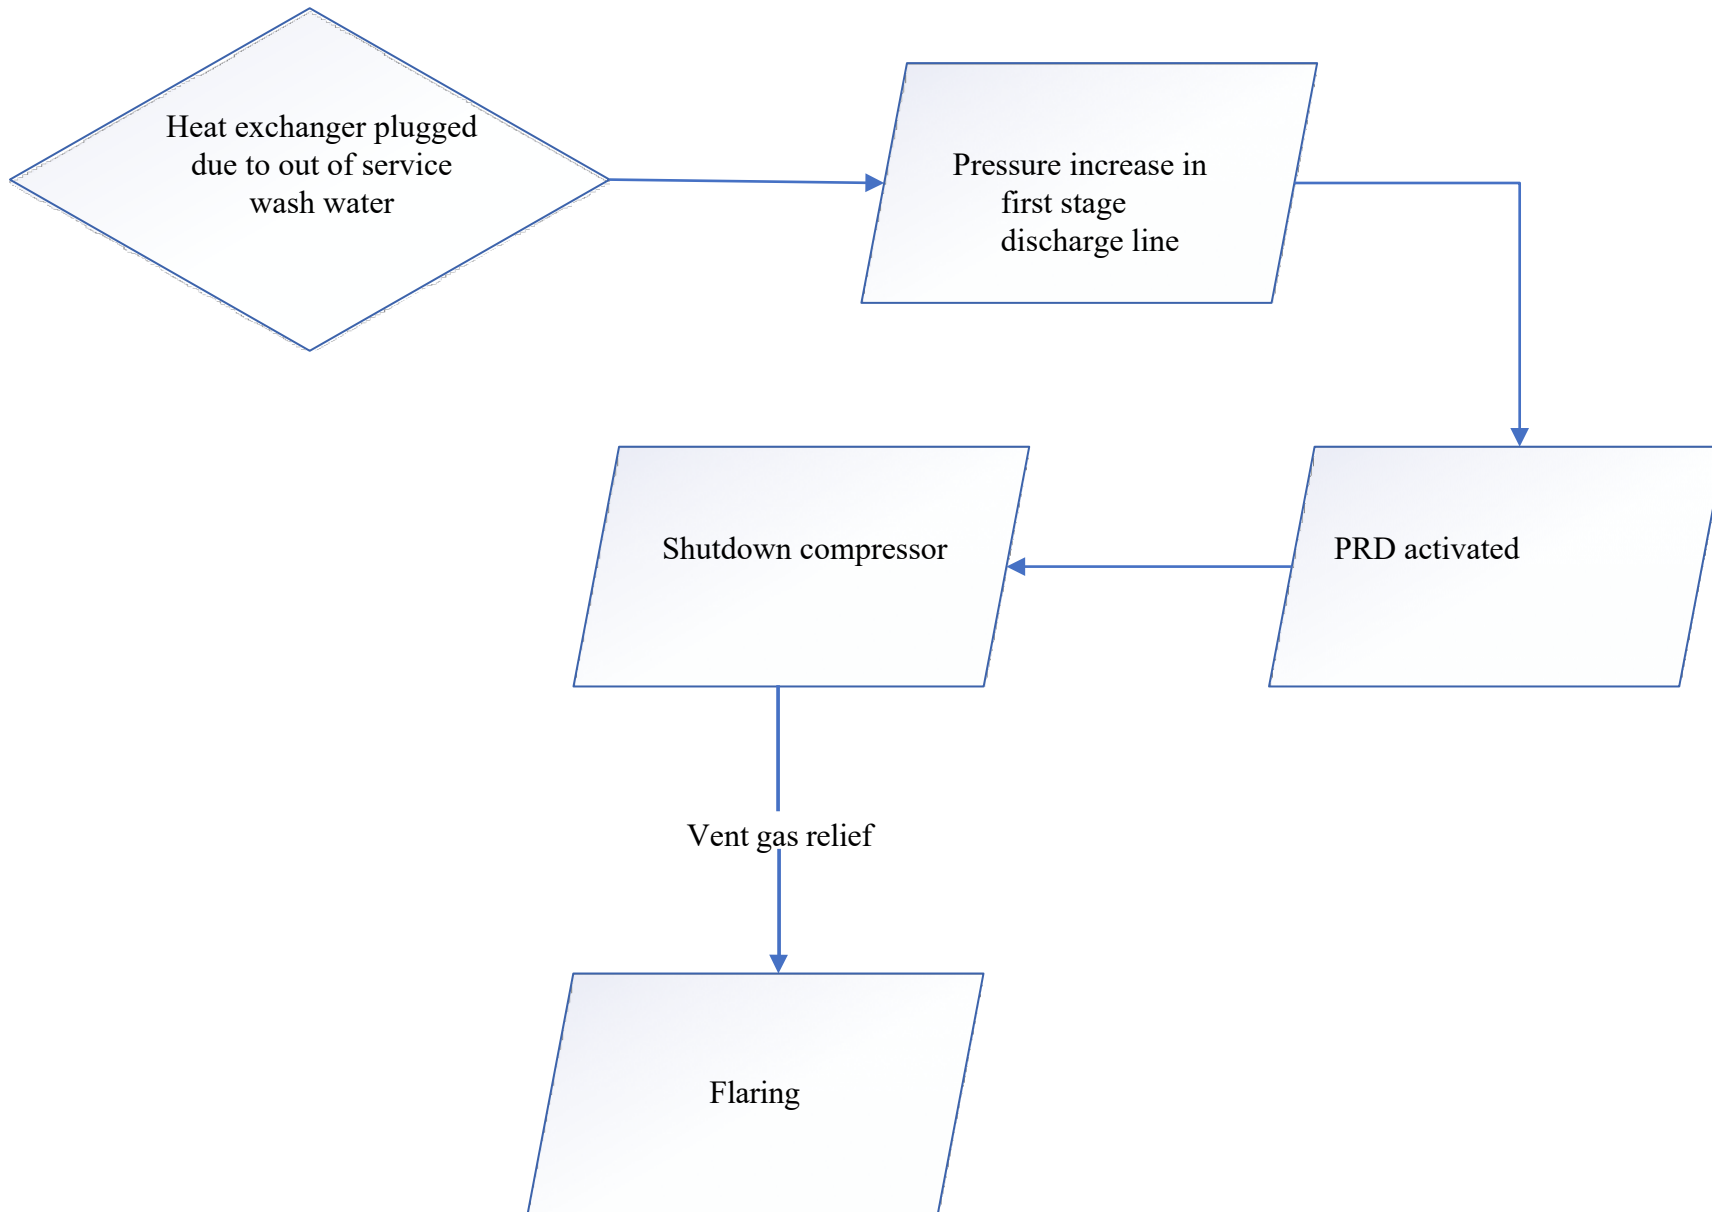
Attachment IIa: Flaring Due to from Heat Exchanger Plugging

On May 22nd, 2025, a heat exchanger got plugged and caused a pressure increase in the first stage discharge line. The pressure increase activated the pressure relief device and shut down the compressor causing the flaring event.

Primary causal factor: The water wash system was out of service causing heat exchanger plugging.

- i. Add a pressure alarm on the heat exchanger discharge.

- ii. Perform engineering evaluation of installation of dp transmitter for the heat exchanger. If a new instrument is required, create a scope input for 2028 RLOP turnaround.

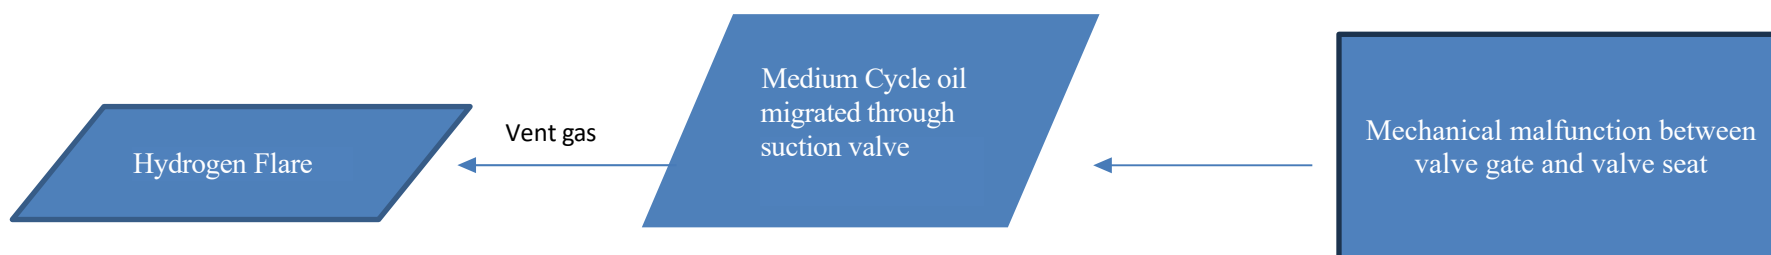
Attachment IIIa: Flaring Due to Mechanical Failure of Suction Valve

A pump within a process unit was being returned to service. During this process, lighter density oil was introduced as the pump was warming up to clear a hydrocarbon blockage that occurred within the pump system. As the hydrocarbon blockage cleared, conditions allowed this lighter oil into the common header of the pump system where it vaporized causing an upset in the pumps system, as well as the associated process column and related equipment. As a result, the process unit was shutdown and gases from the impacted unit were routed to the relief gas system and visible flaring occurred.

Primary causal factor: Lighter density oil (Medium Cycle Oil or MCO) migrated through suction valves that were not fully closed due to a malfunctioning engagement between the valve gate and the valve seat.

Contributing Causal factor: Checklist expectations when using MCO to clear hydrocarbon blockages during the pump warm-up were unclear

1. Perform an engineering evaluation and provide a recommendation on a different design or configuration of the manual block valve that can be used in this application to allow for improved isolation.

2. Evaluate the feasibility of installing a local position indicator to the manual valves to determine the current position.

3. Update the pump warm-up checklist to include clear expectations when using Medium Cycle Oil to clear hydrocarbon blockages.
