**Chevron Richmond Refinery
August 2024 Flaring Causal Analysis Report**

Causal Analysis Report

Chevron Richmond Refinery
Reportable Flaring Events

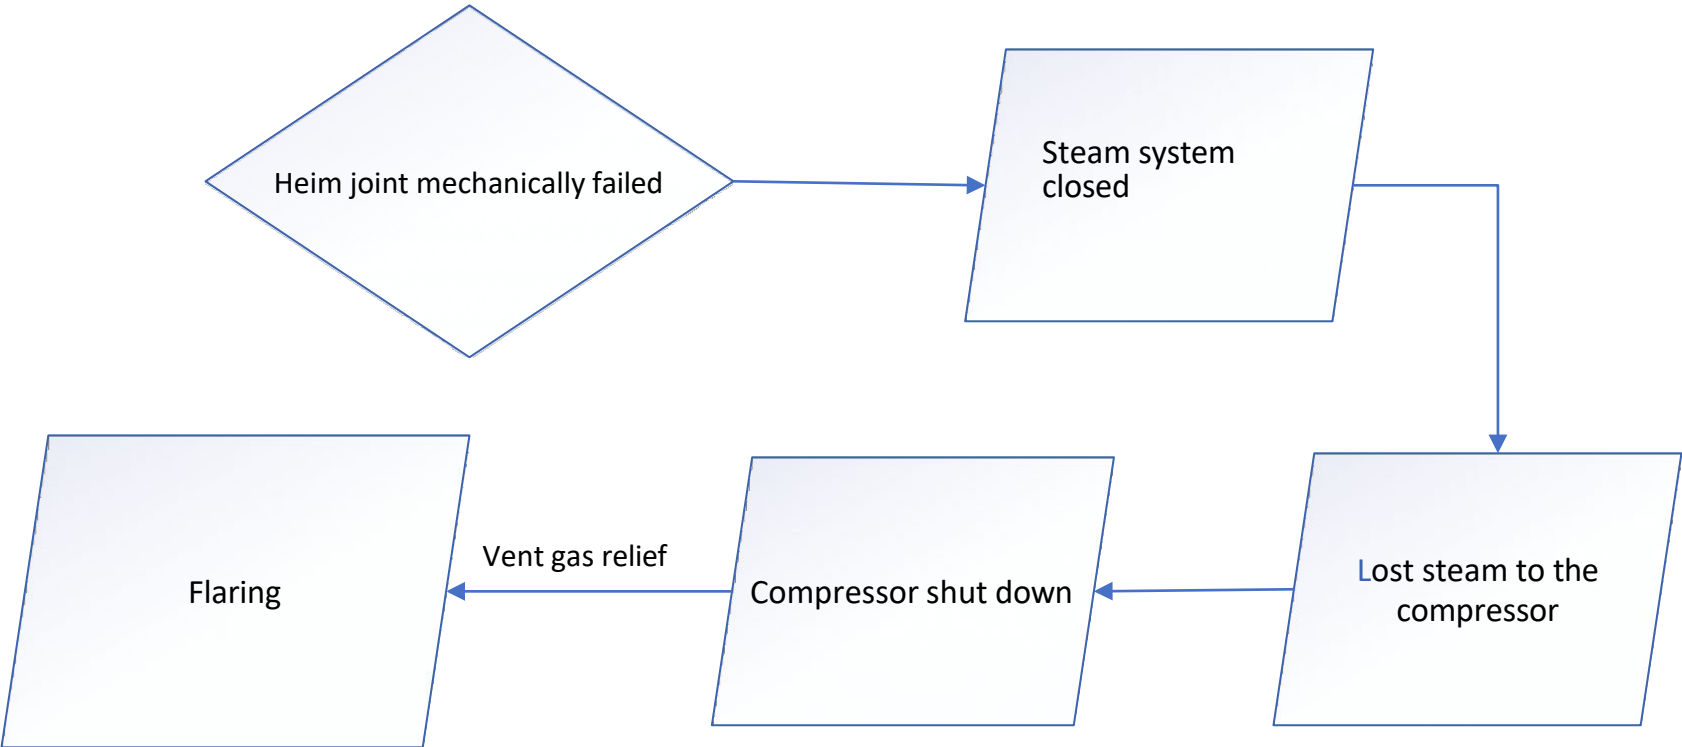
Attachment Ia: Flaring Due to Mechanical Failure of Compressor Steam Rack

On August 02, 2024, a mechanical failure occurred within the steam system associated with a recycle hydrogen compressor.. The mechanical failure caused the steam system to close, shutting down the associated compressor. The loss of the recycle hydrogen stream to the process unit initiated a shutdown of the process unit and led to the flaring event.

Primary causal factor: Mechanical failure of Heim joint within the steam system

The primary contributor of the vent gas to the flare was a hydrocracking unit.

1. Evaluate Heim joint durability for this and similar steam turbine governor linkage systems. Make appropriate updates to standards, if necessary.
 - a. Estimated Completion Date: 12/31/2025

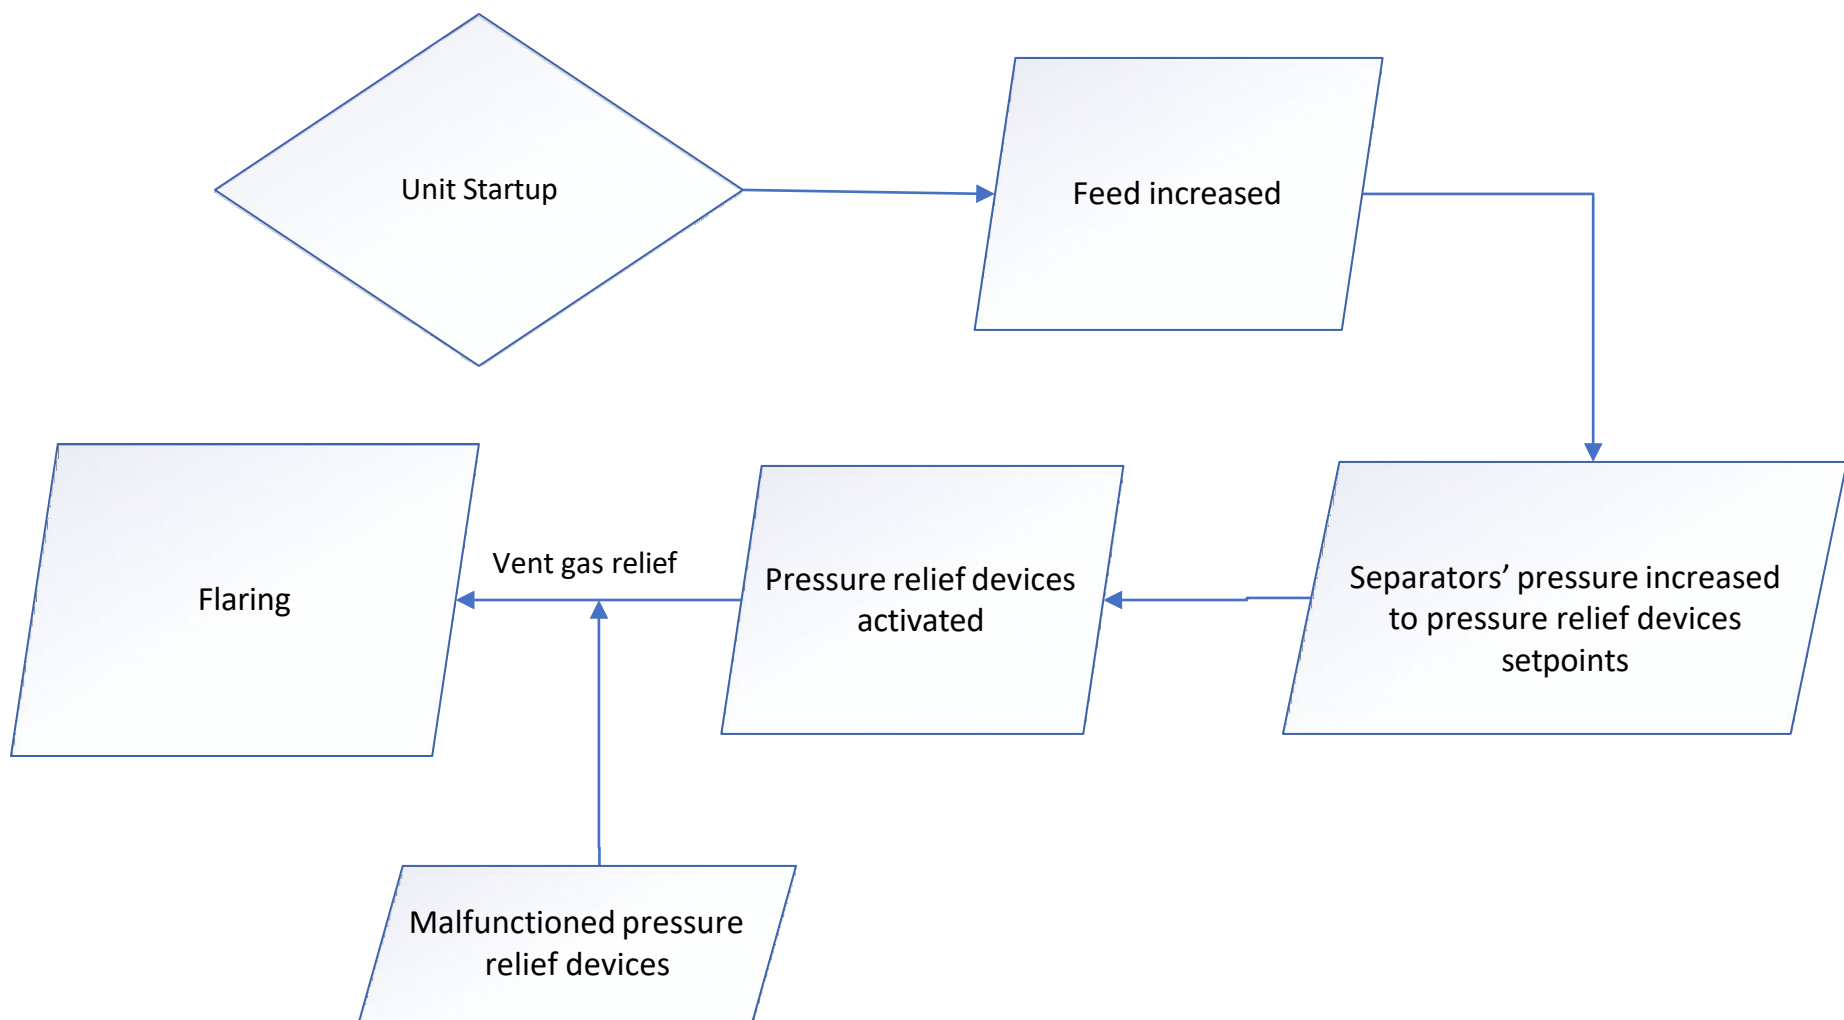
Attachment IIa: Flaring Due to Startup of Process Unit

On August 15, 2024, the startup of a process unit resulted in an increased gas flow to a separation vessel, which subsequently raised the vessel pressure. The pressure increase activated the associated pressure relief devices, leading to flaring.

Primary causal factor: ambiguous guidance in the startup procedure to manage high pressure alarm during startup.

Contributing factor: Pressure relief devices malfunctioned

The primary contributor of vent gas: a hydrocracking unit

1. Revise the startup procedure to include guidelines for managing high pressure alarm on this equipment during startup.
 - a. Estimated Completion Date: 03/31/2025
